JOSEPH RIVET  
 BAY COUNTY DRAIN COMMISSIONER  
 EXHIBIT 14  
 DNRE IMPAIRMENTS

KAWKAWLIN RIVER WATERSHED MANAGEMENT PLAN  
 GLADWIN, MIDLAND, SAGINAW, & BAY COUNTIES  
 MICHIGAN

EXHIBIT 15  
 WINDSHIELD ASSESSMENT  
 AGRICULTURE & LIVESTOCK

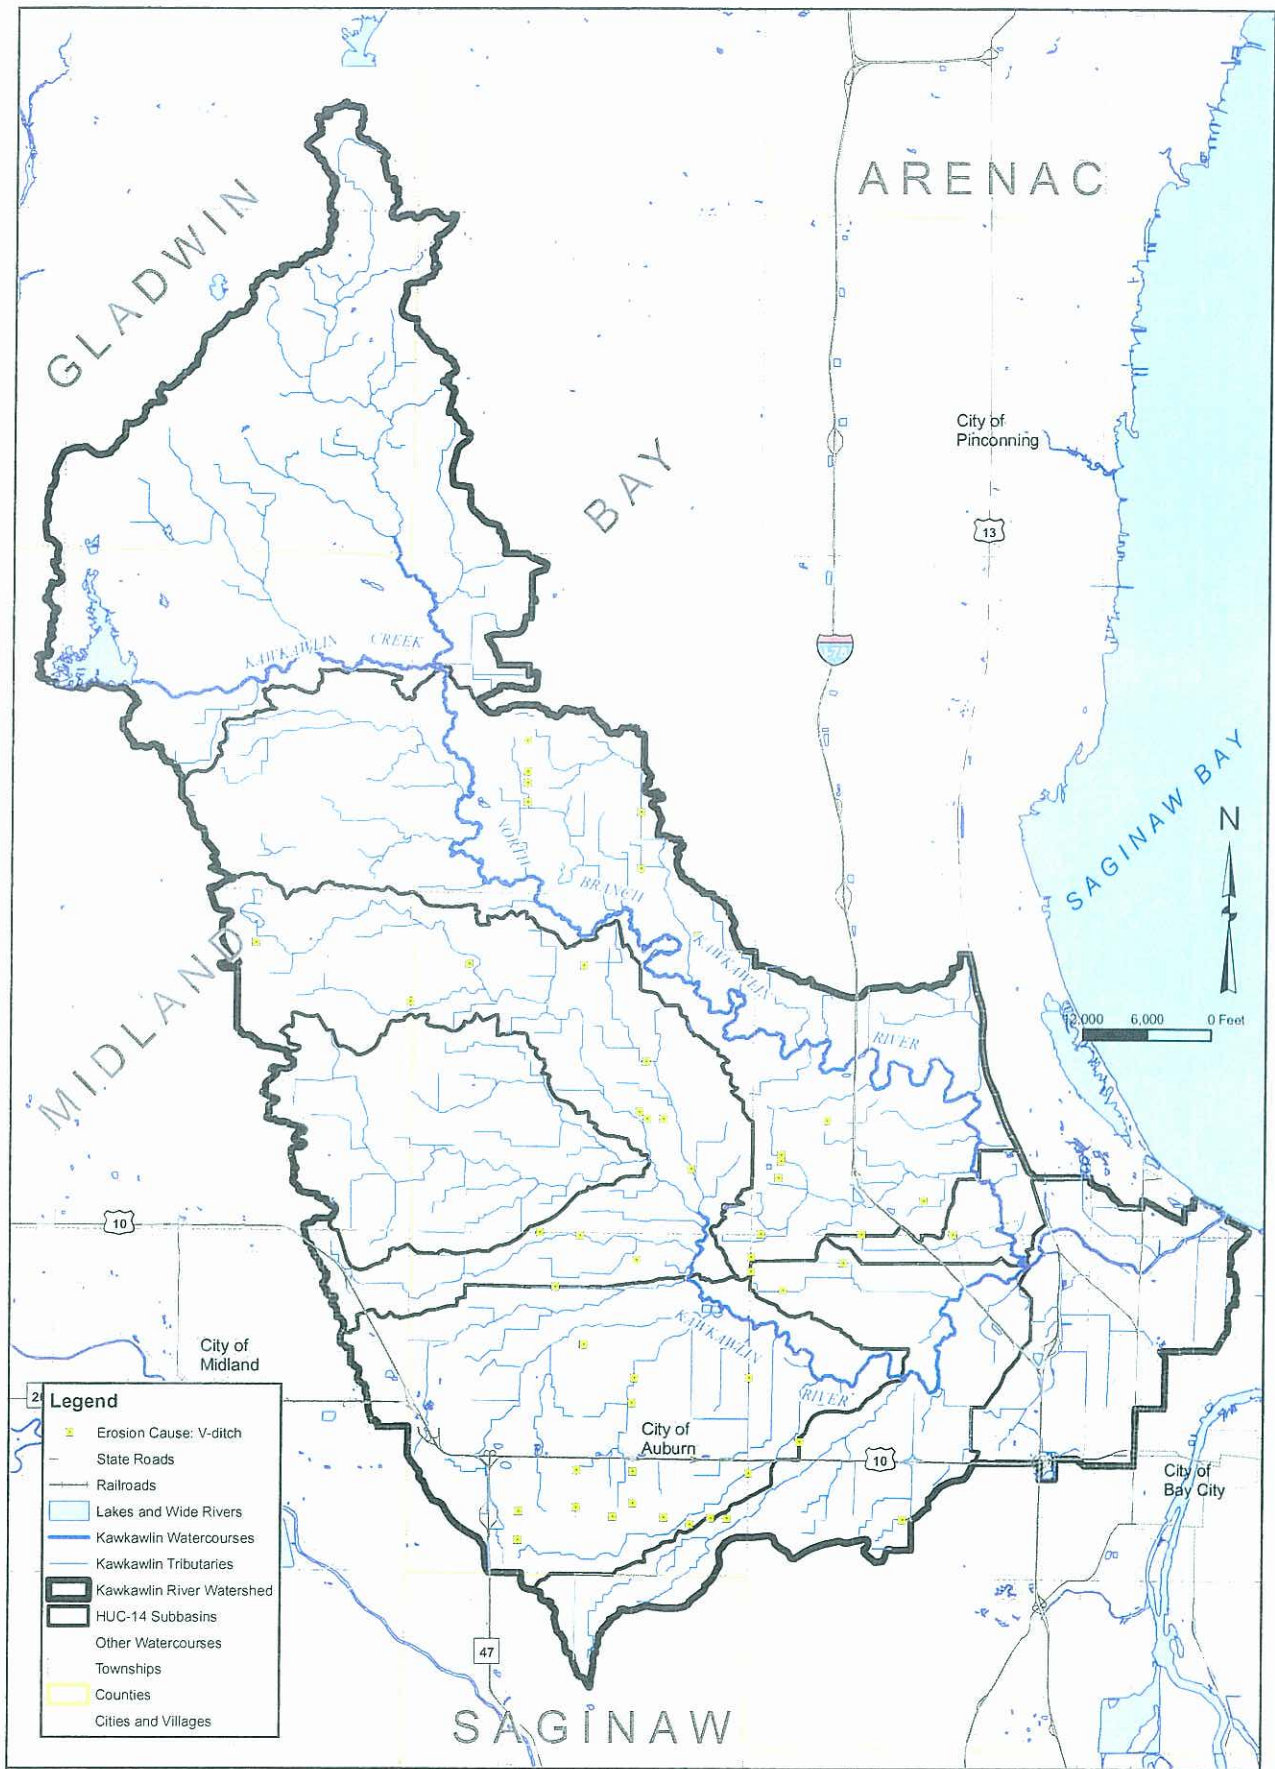
JOSEPH RIVET  
 BAY COUNTY DRAIN COMMISSIONER  
 EXHIBIT 20  
 Windshield Survey Results Part 1  
 Agriculture - Erosion Cause: V-Ditch  
 KAWKAWLIN RIVER WATERSHED MANAGEMENT PLAN  
 GLADWIN, MIDLAND, SAGINAW, & BAY COUNTIES  
 MICHIGAN

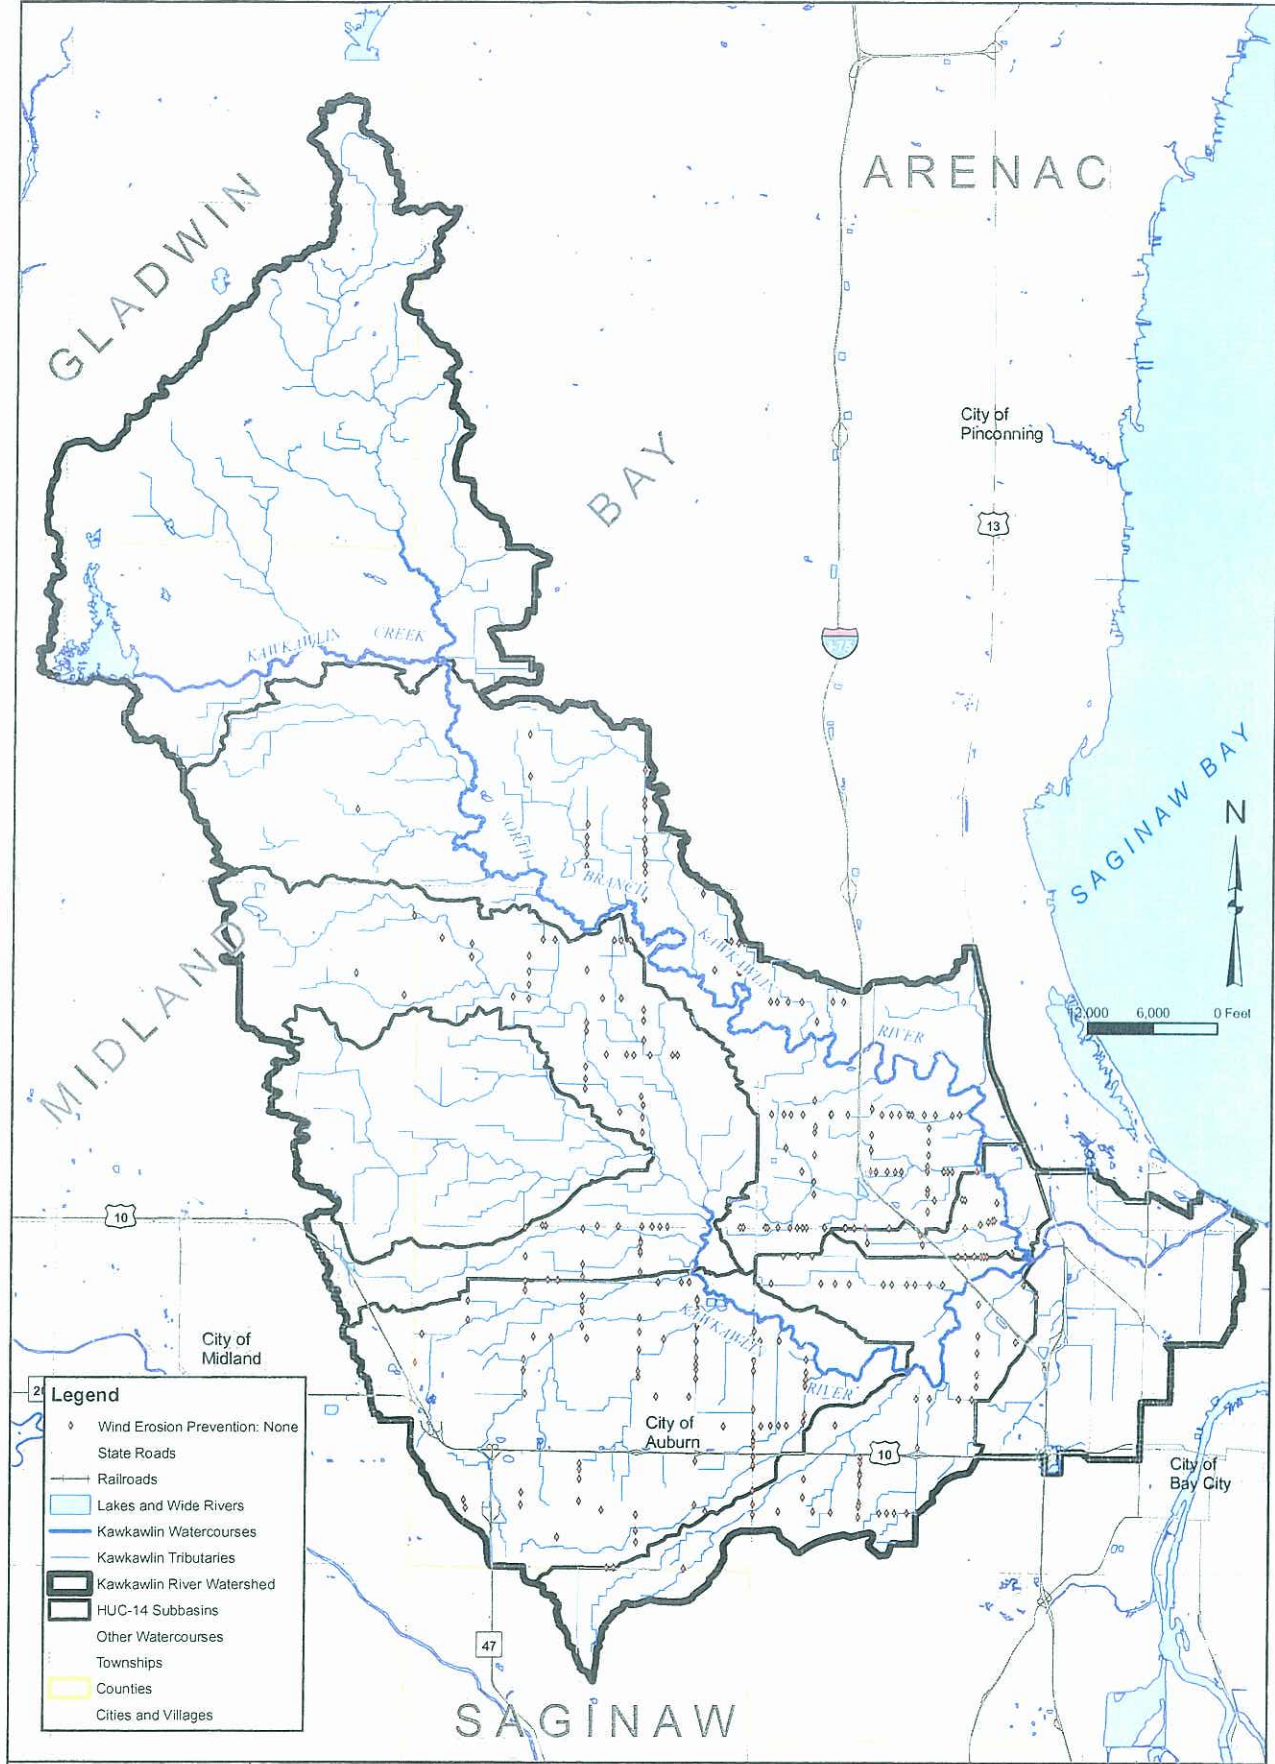
JOSEPH RIVET  
 BAY COUNTY DRAIN COMMISSIONER  
 EXHIBIT 21  
 Windshield Survey Results Part 1  
 Agriculture - No Wind Erosion Prevention  
 KAWKAWLIN RIVER WATERSHED MANAGEMENT PLAN  
 GLADWIN, MIDLAND, SAGINAW, & BAY COUNTIES  
 MICHIGAN

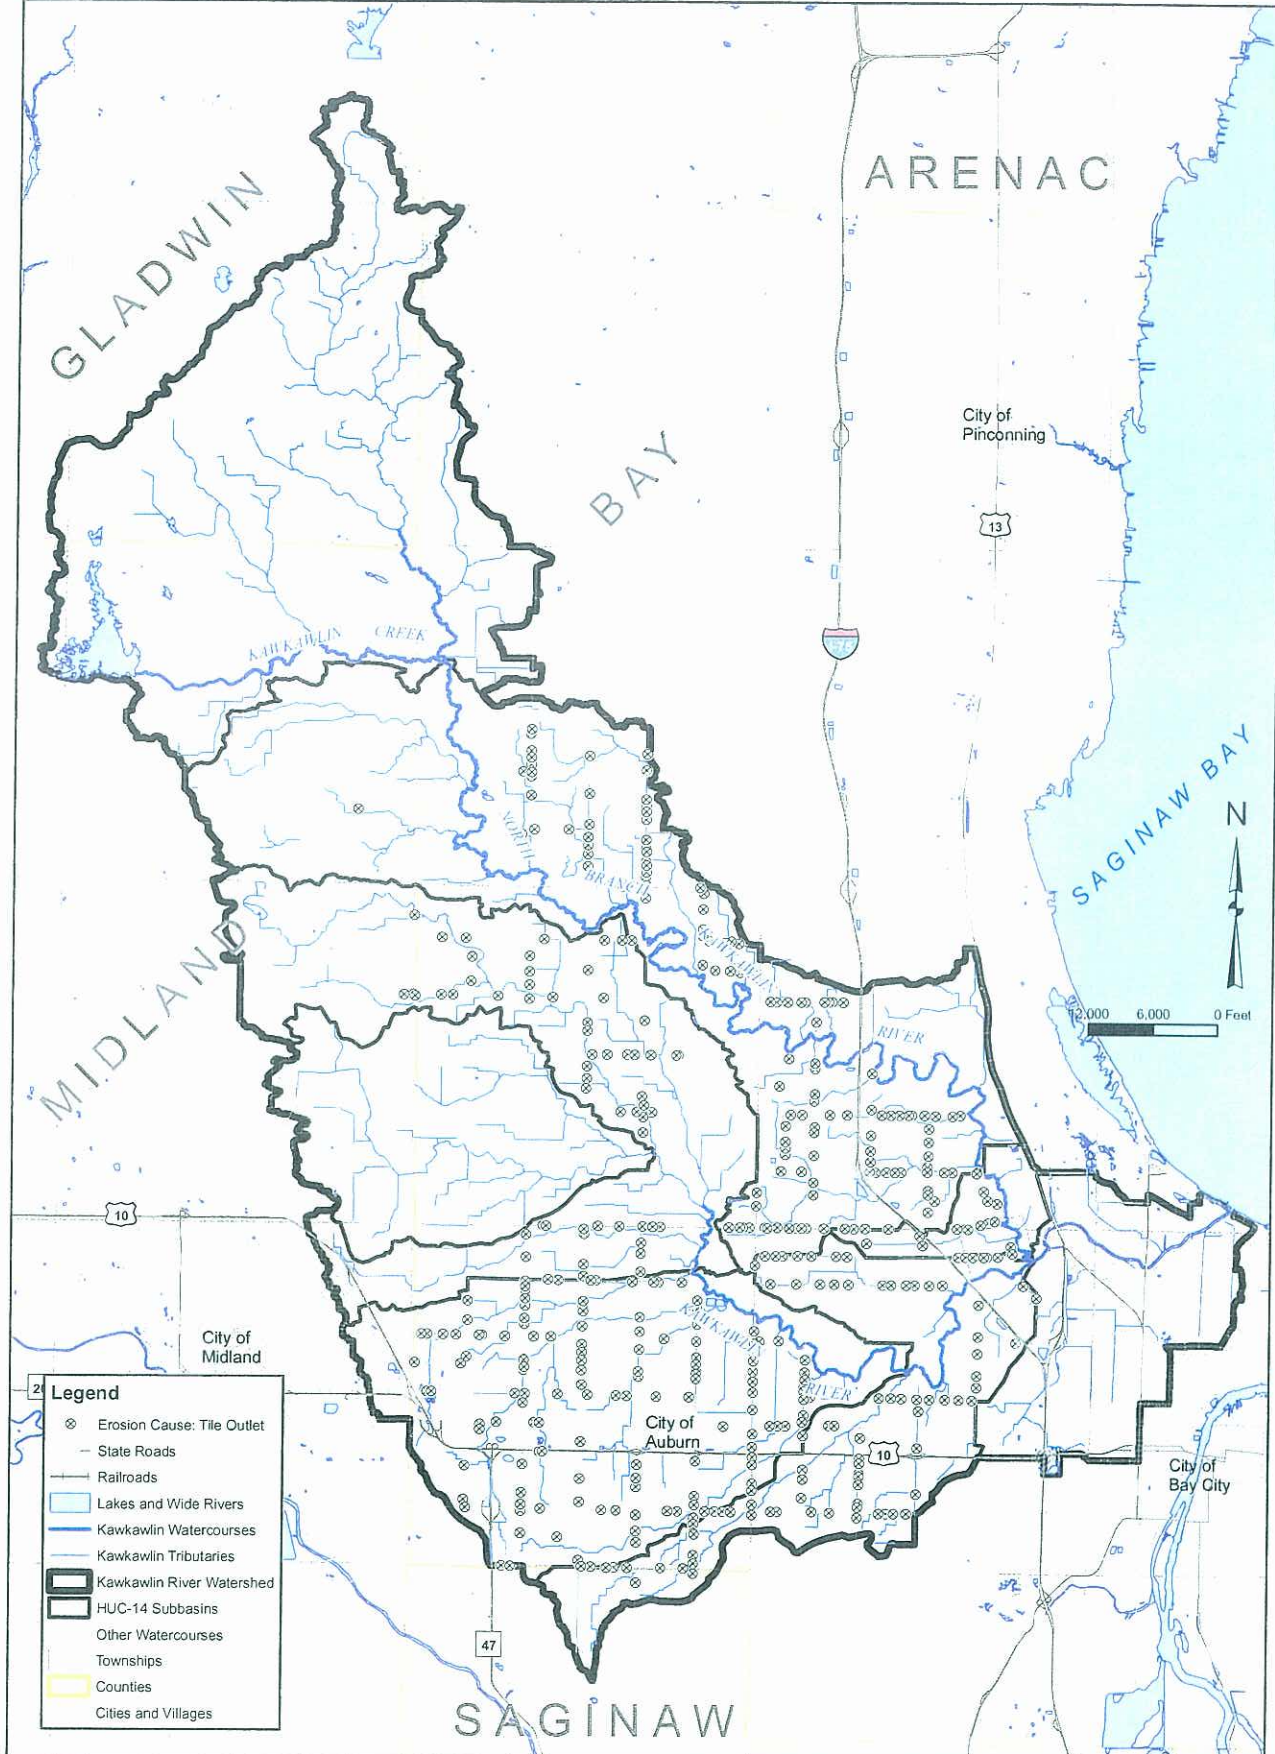
**EXHIBIT 22**  
 Windshield Survey Results Part 1  
 Agriculture - Erosion Cause: Tile Outlet

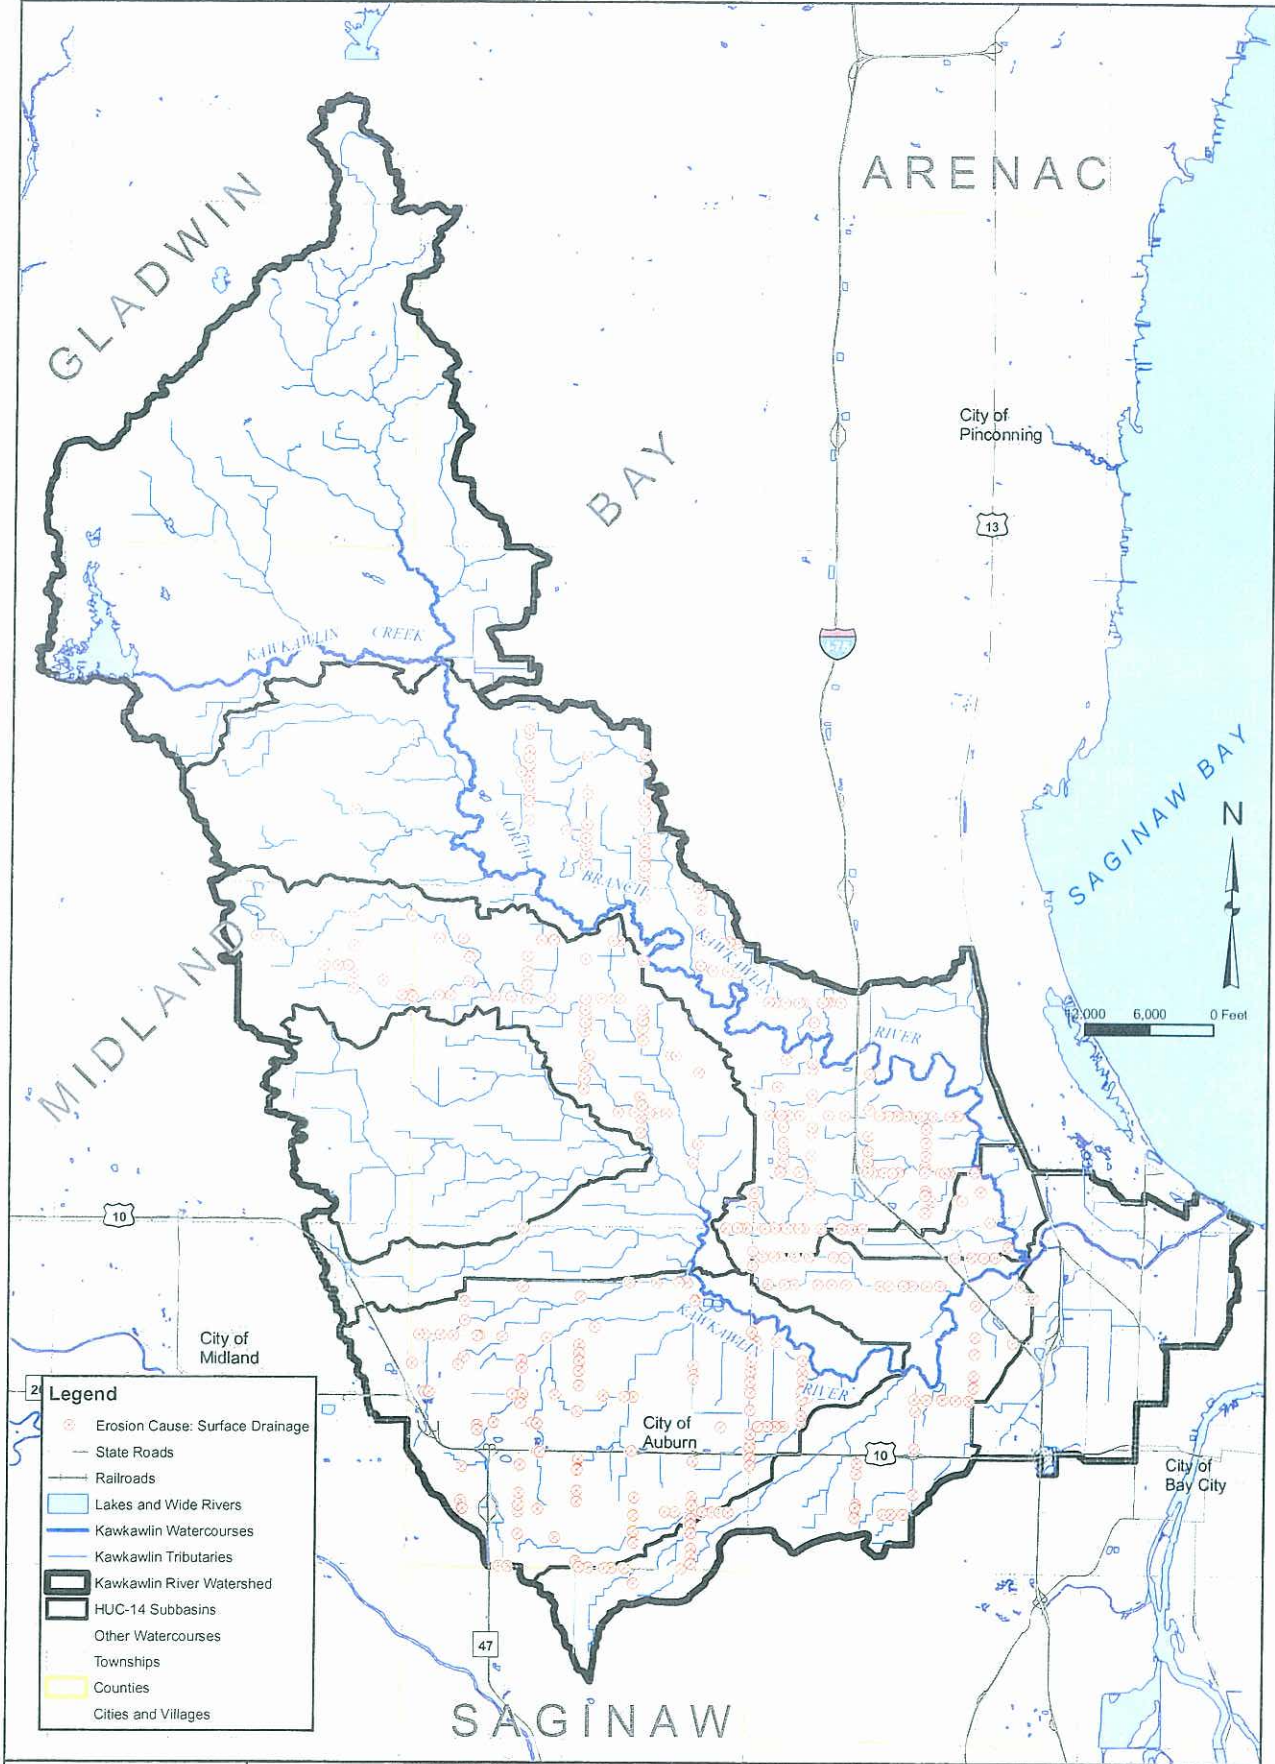
JOSEPH RIVET  
 BAY COUNTY DRAIN COMMISSIONER  
 EXHIBIT 23  
 Windshield Survey Results Part 1  
 Ag. - Erosion Cause: Surface Drainage  
 KAWKAWLIN RIVER WATERSHED MANAGEMENT PLAN  
 GLADWIN, MIDLAND, SAGINAW, & BAY COUNTIES  
 MICHIGAN

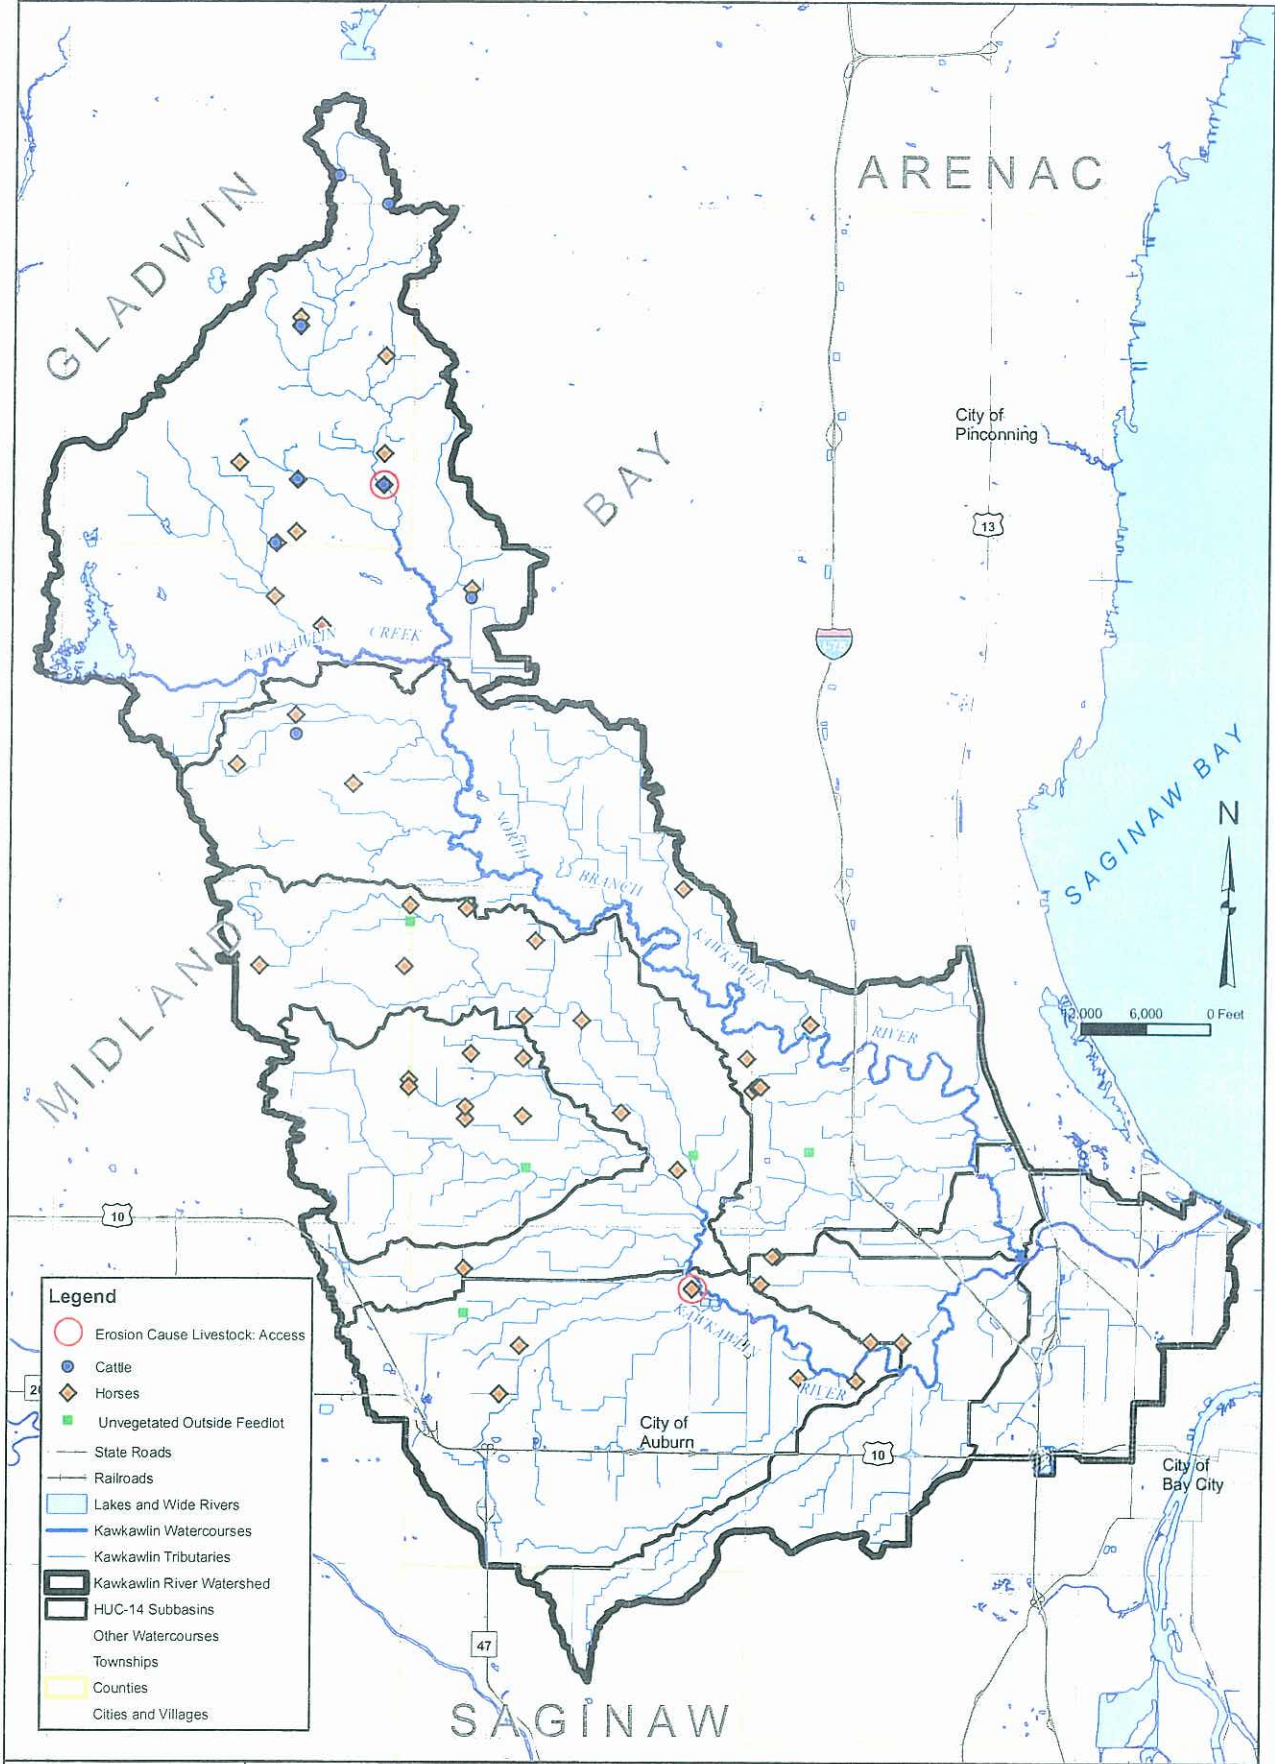
JOSEPH RIVET  
 BAY COUNTY DRAIN COMMISSIONER  
 EXHIBIT 24  
 Windshield Survey Results Part 2  
 Livestock  
 KAWKAWLIN RIVER WATERSHED MANAGEMENT PLAN  
 GLADWIN, MIDLAND, SAGINAW, & BAY COUNTIES  
 MICHIGAN

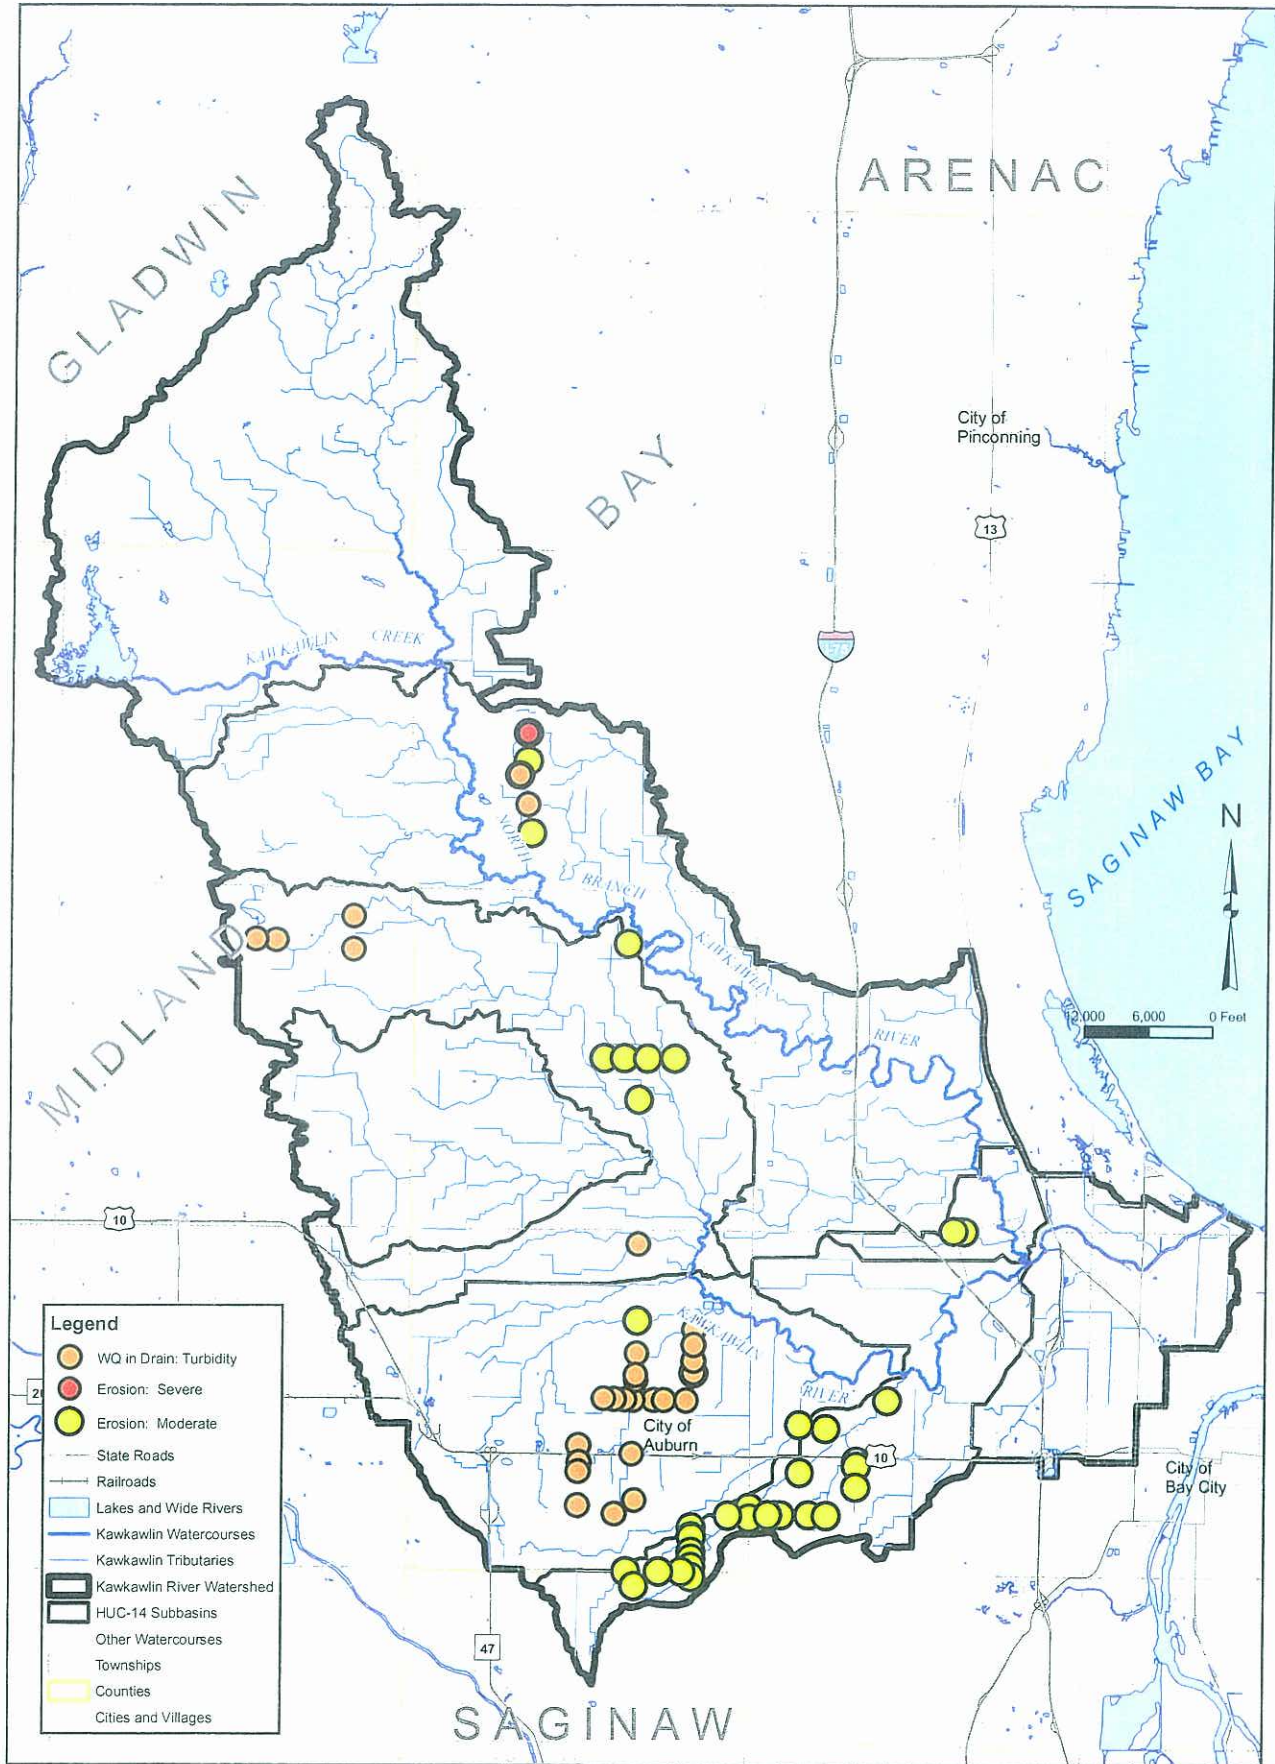
EXHIBIT 25  
 Windshield Survey Results,  
 Part 3: Indicators
